Manhole Inspection Summary

Manhole # S1900_023MH

Location Address: **2011 ELGIN-WHITTIER**

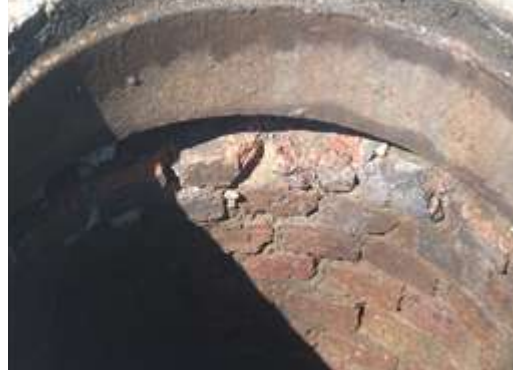
Defect 1

Condition: ☐ Sound ☐ Cracked ☐ Root Intrusion ☐ Loose Brick ☒ **Deteriorated**

DETERIORATION OF CORBEL

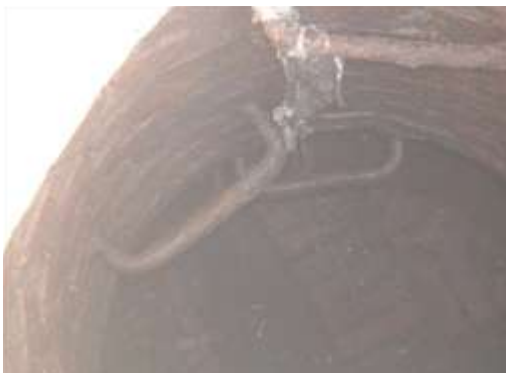
Steps Count: **4** Missing: **0** ☒ **Corroded**

Surcharge ☒ **Evidence Of Surcharge** Depth: **4** (ft.) ☐ Active Surcharge Present

CORRODED STEPS AND SURCHARGE
EVIDENCE

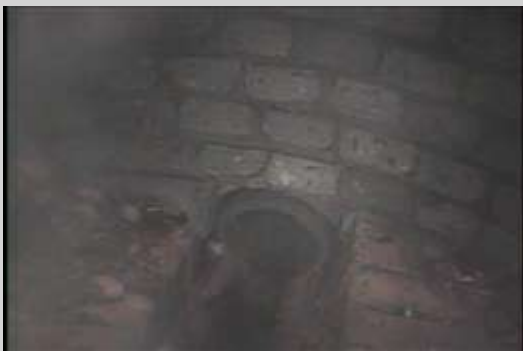
6 O'Clock Inflow

6 in. Circular Gravity Sewer
Pipe In @ 6 O'Clock

Pipe Height: **6** (in.) Rod and Bar (Angled)
Pipe Material: **Clay** ☐ Pipe Lined
Invert Depth: **10.26** (ft.) Flow Characteristics: **Slow**
Deposits: ☒ **None** ☐ Mud ☐ Sludge ☐ Debris ☐ Grease
Silt Depth: (in.) Deposits Extent:
Infiltration: **None** Pipe Seal Cond: **Sound**

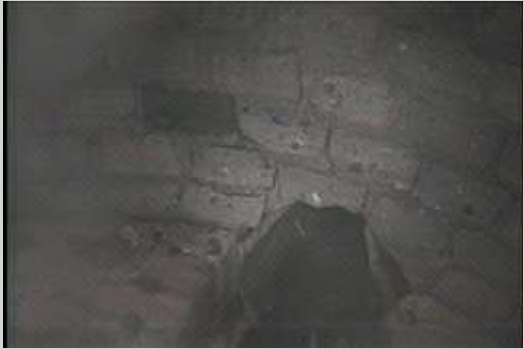
9 O'Clock Inflow

8 in. Circular Gravity Sewer

Pipe In @ 9 O'Clock

Infiltration: **None** Pipe Seal Cond: **Broken**
